**SAS Superstructure**

Location: 04-SF-80-13.2 / 13.9

Daily Diary Report by Bid Item

Diary #: 576 Const Calendar Day: 981 Date: 16-May-2012 Wednesday

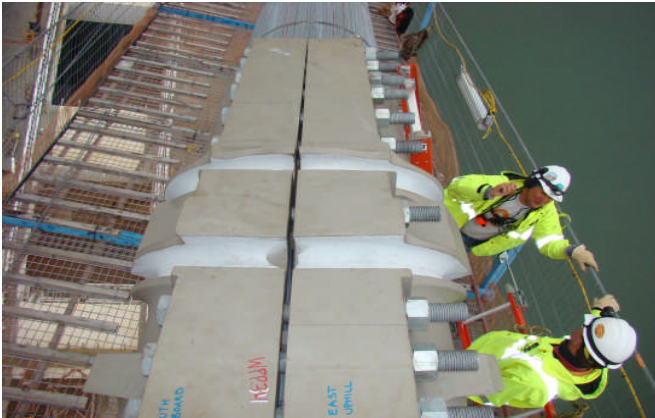
Dramatic difference in the top gaps of cable band 34N where the band closed together similar to a wedge.

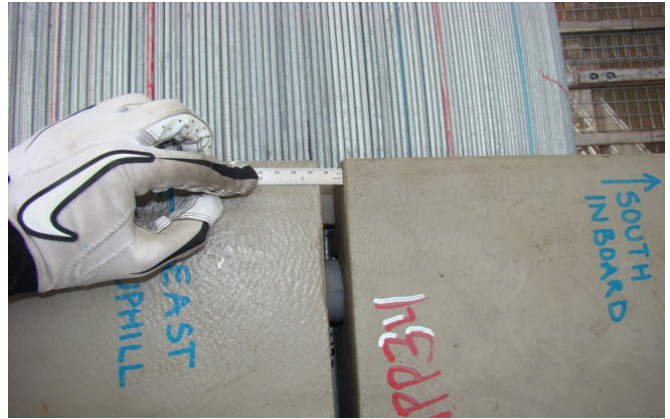
Measured Uphill gap of cable band 34 where the measurement was 14mm.

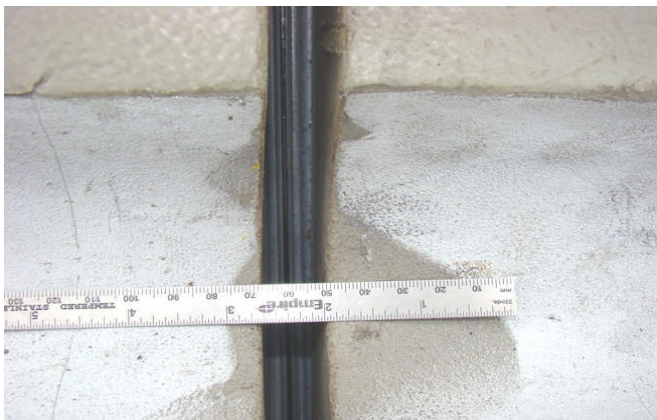
Measured gap of cable band 34 at the Uphill suspender rope groove where the gap measurement was 15mm and the rotation centerline was at 7mm.
